OBSERVATIONS ON EROSION PATTERNS IN BAYER SLURRIES

O.C. Celliers

Alcoa, Cockburn Rd, Naval Base WA 6165, Australia.

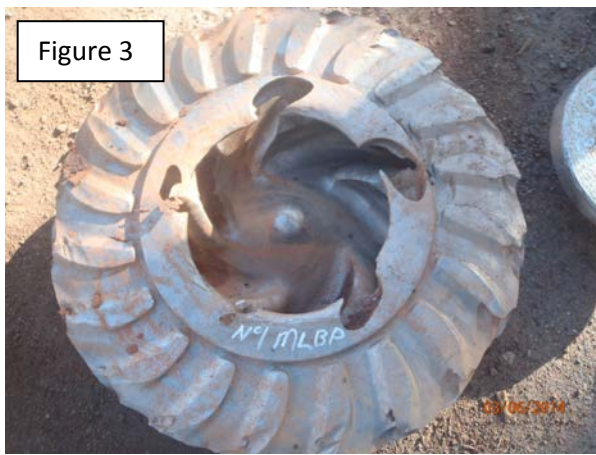
damage shows that flow modes much more intricate than direct impingement or sliding are involved. Figure 3 shows an impeller from a slurry pump, with clear vortex damage. Figure 4 shows the cover plate on a slurry pump, with erosion ripples. Figure 5 shows another impeller, with ripple damage with the ripples inside vortices, and figure 6 shows erosion ripples inside a vortex gouge in a slurry pump volute. These are not isolated cases, a quick look through a refinery scrap metal bin will show numerous examples of such erosion damage.

Figure 3. Slurry pump impeller with vortex damage

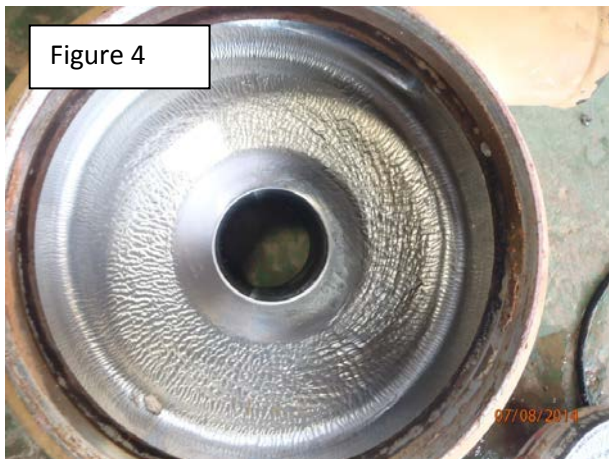
Figure 4. Erosion ripples

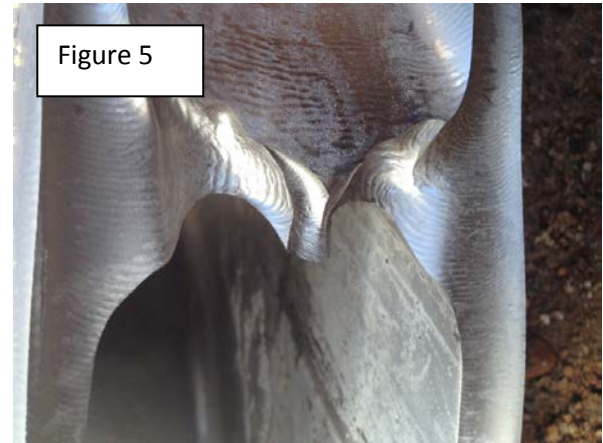
Figure 5. Erosion ripples and vortices

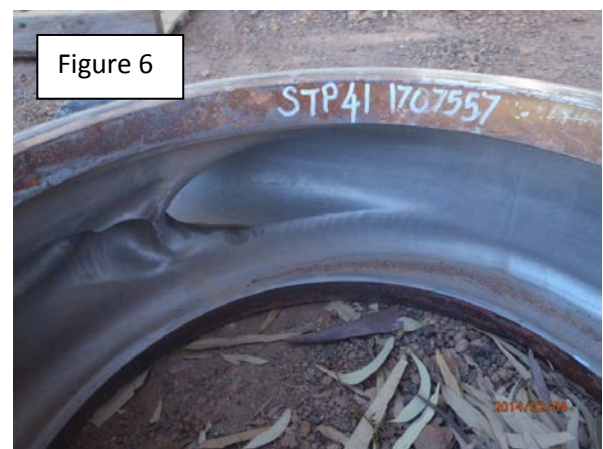
Figure 6. Erosion vortices at the cutwater of a pump volute

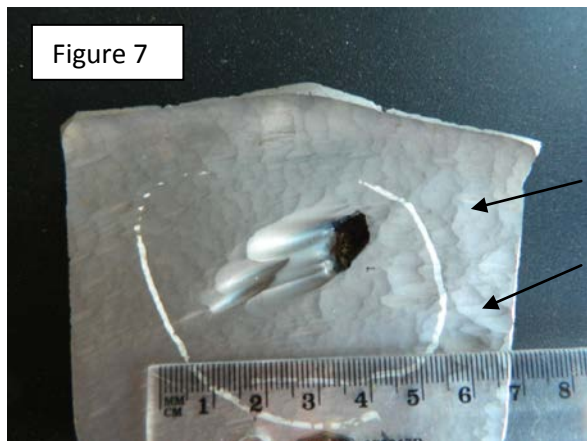
Figure 7. Erosion damage on a slurry pump part

Figure 7 shows a section from a slurry pump throatbush, material 27Cr, with a major casting defect and the associated vortices that formed. Of interest here though is the ripples and vortex gouges that formed away from, and irrespective of, the defect, as indicated by arrows. The ripple lines are roughly perpendicular to the direction of flow (the direction of movement of the impeller relative to the throatbush), and appear to have degenerated in some areas into small vortex gouges a few millimetres in size. Similar vortex gouges can be seen in figure 20.

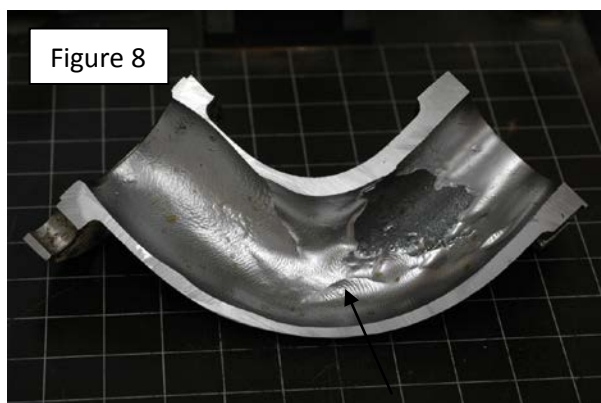
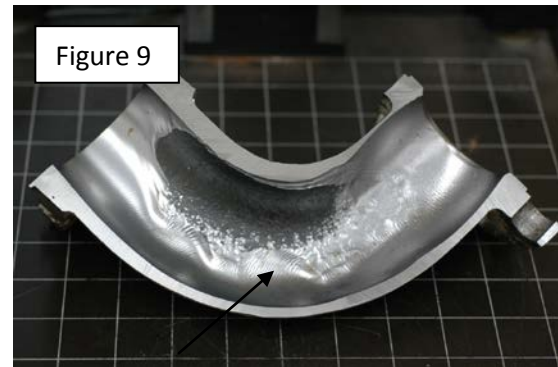
Figures 8 and 9 show an elbow from a hydrate slurry line. The arrows indicate what are assumed to be vortex gouges. Erosion ripples are clearly visible inside these gouges, and it is observed that the ripple lines run roughly parallel to what would have been the direction of swirl in the vortices, ie perpendicular to the vortex axis.

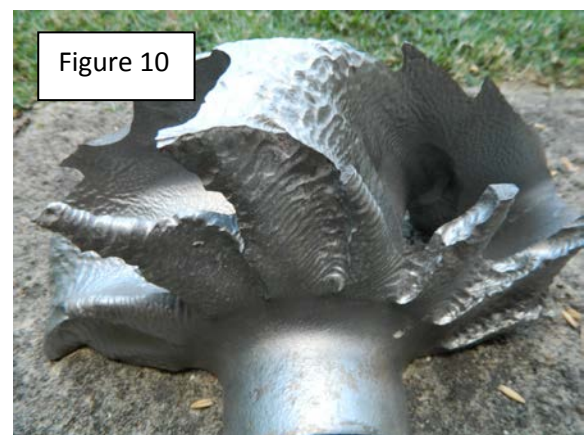
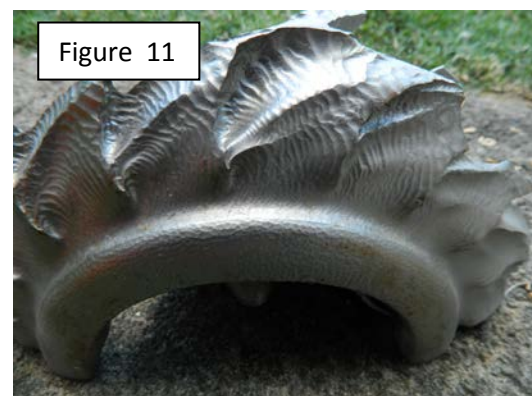
Figures 10 and 11 show an impeller from a hydrate slurry pump, with massive vortex damage to the front and back shroud (and much less damage to the vanes). Ripples are seen inside the vortex gouges, with the ripple line more or less perpendicular to the vortex axis, and with the ripple peak to valley distance (the ripple depth) ranging from a largely optical effect to more than a millimetre.

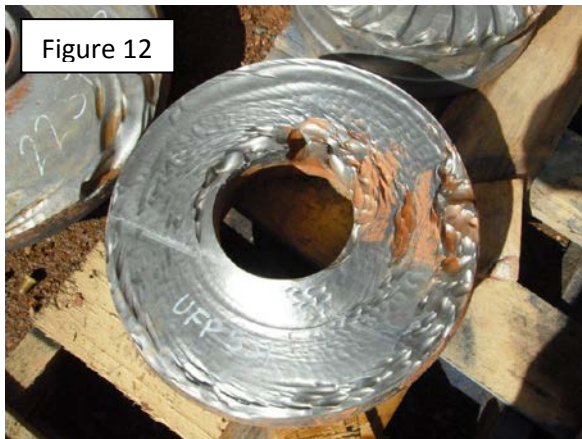
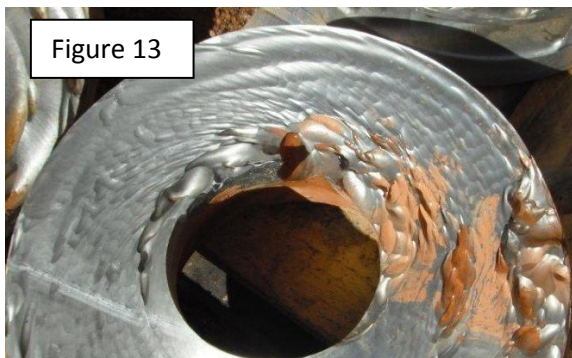
Figures 12 and 13 show a throatbush from a mud slurry pump. Ripples are visible, as well as a spiral pattern of small and shallow vortex gouges that degenerate into a chaotic pattern of large holes.

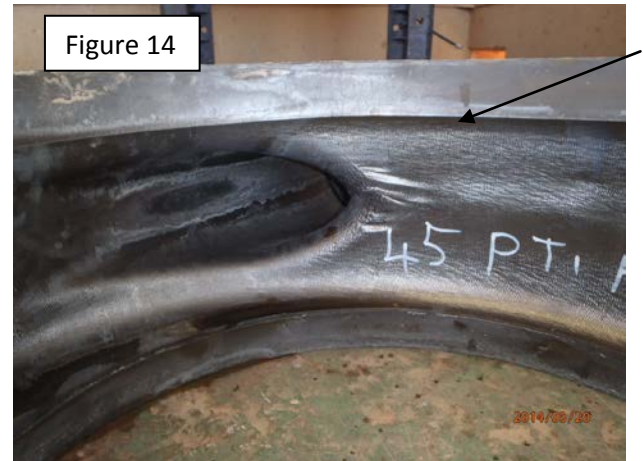
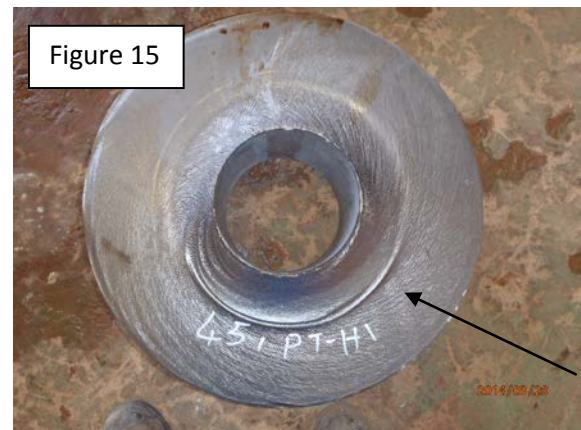
Figures 14 and 15 show the fine ripple on pump parts from a hydrate slurry pump.

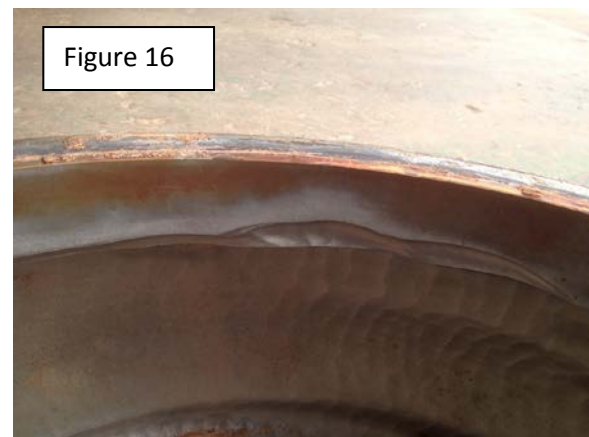
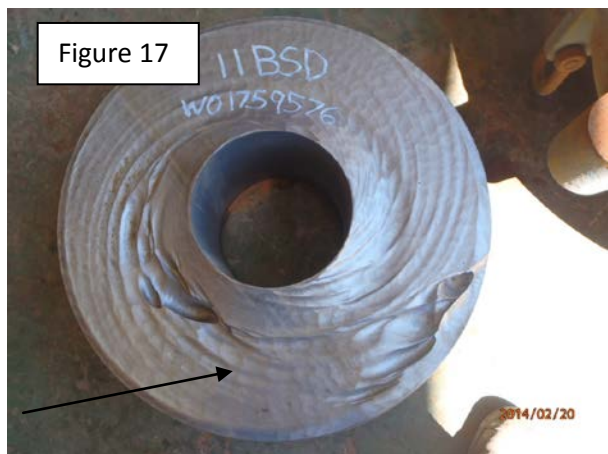
Figures 16 and 17 show the much coarser ripple on a bauxite-slurry-to-digestion pump parts.

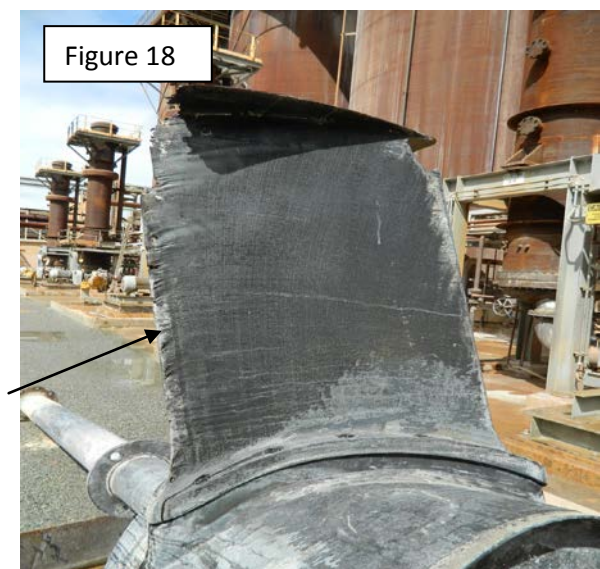
Figure 18. Precipitation tank blade

Figure 18 shows a blade from a precipitation tank mechanical agitator, with vortex erosion damage along the leading edge.

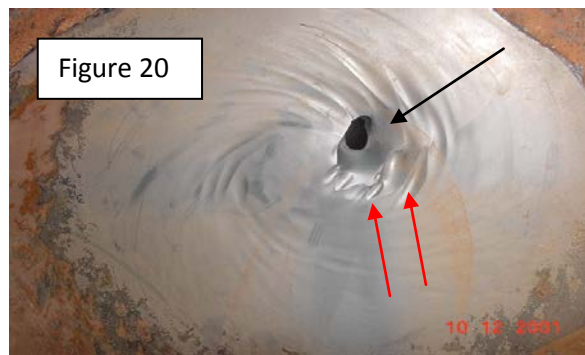
Figure 20. Eroded blank from a blind T

Figure 20 shows an example of vortex erosion observed on a blind T blank, indicated by a black arrow. The vortex apex has drilled a hole through the steel. Notice also the much smaller vortex gouges, indicated by red arrows, that appear to have been formed by vortices with axes more or less in the plane of the blank.

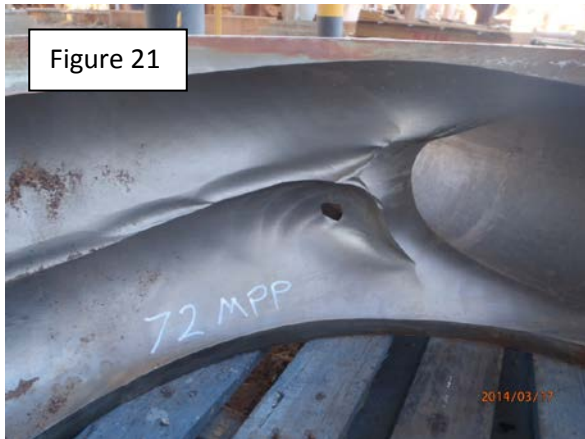
Figure 21. Mill product pump volute

Figure 21 shows a 'horseshoe vortex' in a mill product pump, where the eroding particles can be mill scats several millimetre in diameter. Figure 22 shows the much finer vortex gouges at the cutwater in the volute of a hydrate pump. Also notice the erosion ripples inside these vortex gouges.

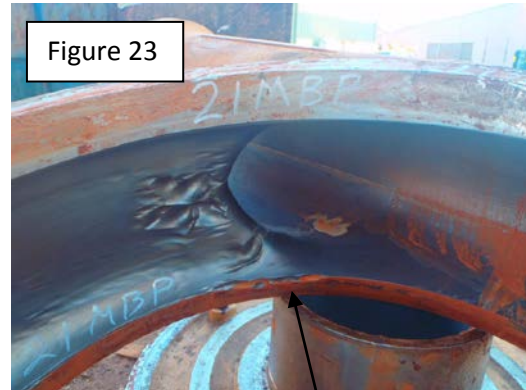
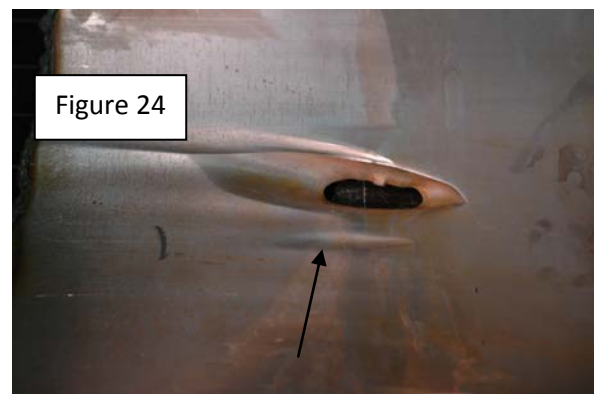
Figures 23 and 24 show secondary vortices that have formed some distance from the main vortex.

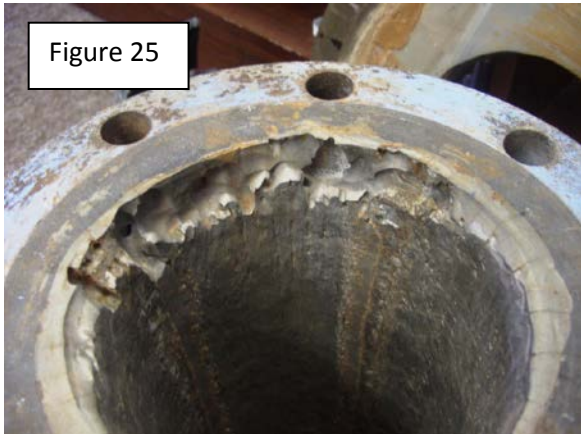
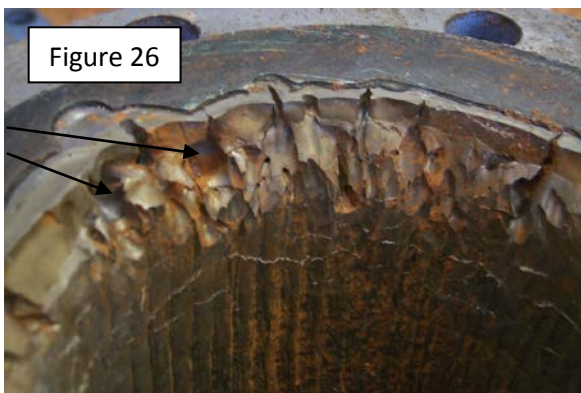
Figures 25 and 26 show ball-shaped depressions in the hardfacing on a slurry spool that could have been formed by stationary turbulence, or an eddy that stays in the same location over time. Figures 27 to 32 show similar erosion gouges in different slurry pump parts.
