## CAUSTIC EMBRITTLEMENT IN THE BAYER INDUSTRY

Roach, G.<sup>1</sup>, Rubenis, G.<sup>2</sup>, Mastin, P.<sup>3</sup>, Byrne, R.<sup>3</sup>

### Abstract

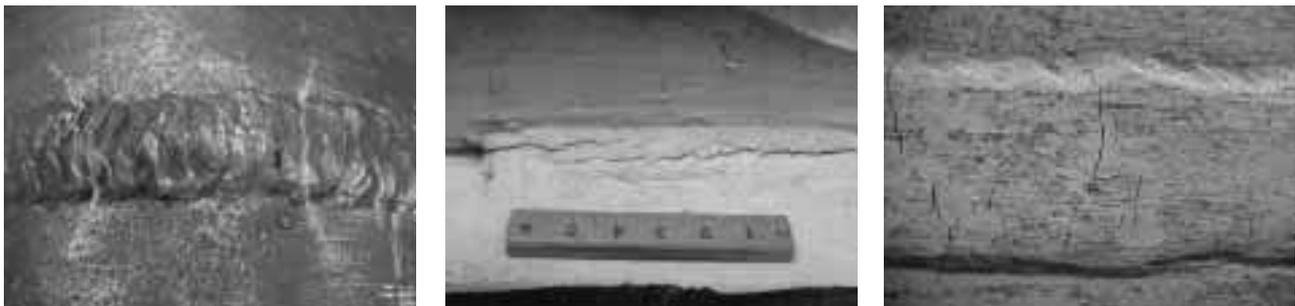
Figure 1 — Examples of stress corrosion cracks in a 50% caustic pipe, a caustic cleaning tank and from a precipitator.

Caustic embrittlement is the common terminology for stress corrosion cracking of steels in a caustic soda solution. Some typical examples of caustic embrittlement cracks are shown in Figure 1. In caustic embrittlement the metal loses strength because cracks propagate along grain boundaries. As these intergranular cracks grow, the available load-bearing cross-sectional area is reduced and failure may result by tensile overload or penetration of the cracks through the walls of containment vessels. The mechanism is still much in debate, the most widely accepted theories being that caustic embrittlement is a form of hydrogen embrittlement or results from anodic dissolution. What is clear is that after a time cracks initiate in the embrittled metal and propagate in an intergranular manner (Figure 2) with the grains effectively becoming unglued from each other. There is not a single crack tip but extensive branching with multiple crack paths; the metal is embrittled often many millimetres in front of the crack tip. Simply heating of the metal results in the cracks extending and opening up in this embrittled area. Attempts to repair the crack by welding can result in further crack propagation. Because of the branching and the intergranular nature of the cracks, prediction of the effect of the crack on the structural strength of the material is difficult and standard crack propagation models are not applicable.

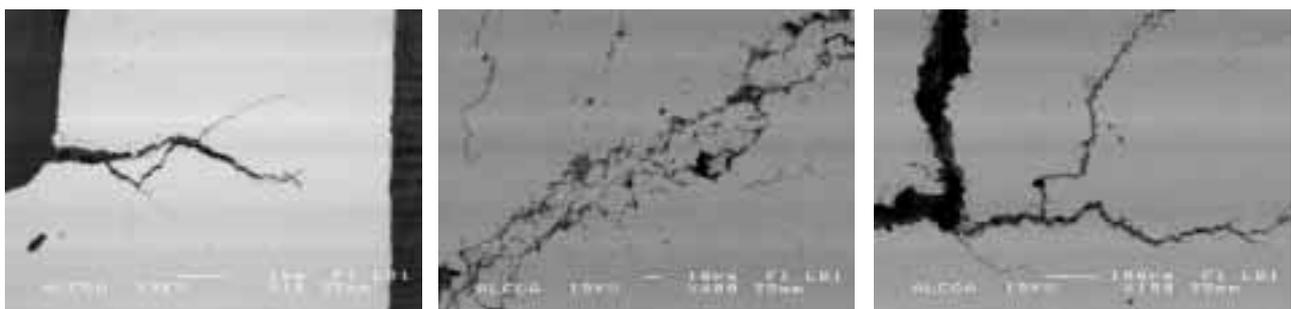
Figure 2 — Branching and intergranular nature of caustic embrittlement crack at a weld.

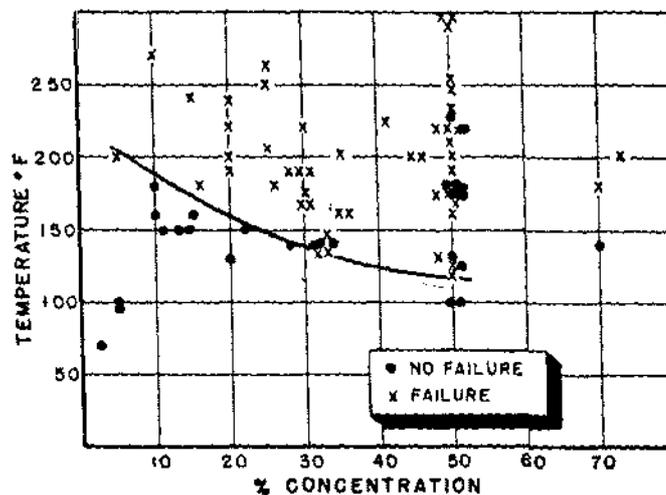
Figure 3 — The NACE chart for caustic embrittlement (NACE, 1951).

In order to get a better understanding of the magnitude and the variability of caustic cracking NACE undertook a survey of processes using caustic solutions including the Bayer industry and produced their seminal paper (NACE, 1951). Further reviews on caustic embrittlement have been undertaken for NACE (eg Parkins, 1977). The NACE survey found that caustic cracking was particularly prevalent at liquor concentrations above 15% NaOH and close to the boiling point, Figure 3. Variants of this Figure have been used for many years as a guide for stress relieving. A similar diagram is used for stainless steels (eg Schillmoller, 1996). There have been further studies that have incorporated more data and further refined these diagrams to cover a broader set of conditions more relevant to the Bayer Industry.

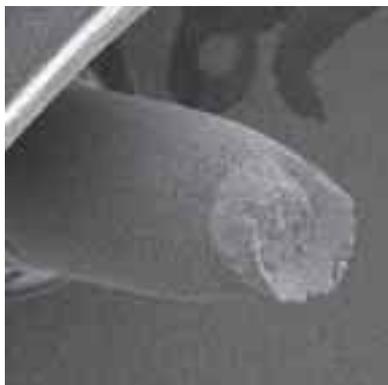
Significant necking of sample, failure is ductile in nature.

Figure 4 — Sample tested in caustic cleaning solution at 80°C.

The data from the CAMT work, and the in plant testing data will be published both at relevant alumina processing meetings and within the materials literature. Currently the CAMT work has focused on caustic cleaning solutions at temperatures below their boiling points. Such solutions are known to cause caustic embrittlement and alumina producers have different upper limits for such cleaning liquors (both temperature and caustic concentration). Also stress relieving requirements in such cleaning systems vary between alumina producers. Examples of the type of information from the work at CAMT for mild steel in a caustic cleaning liquor at a high and low temperature are shown in Figures 4 and 5. Industry experience has shown that caustic embrittlement can readily occur at the high temperature with the caustic concentration used but not at the low temperature. At the low temperature (Figure 4) the fracture is typical of a ductile failure. At the higher temperature the time for failure and %reduction in area were dramatically reduced and there was extensive cracking and embrittlement of the material (Figure 5). The initial part of the failure cross-section for this sample clearly indicates that there has been extensive intergranular cracking. These results are in line with industry experience.

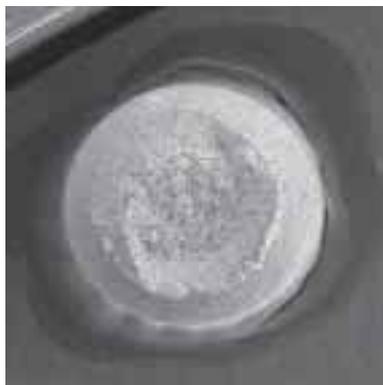
Fracture surface showing only one mode of failure, and typical of a ductile failure.

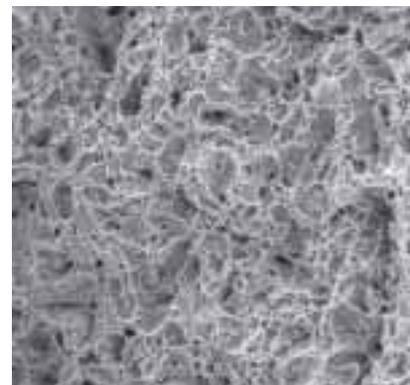
Micrograph of fracture surface showing typical ductile dimples.

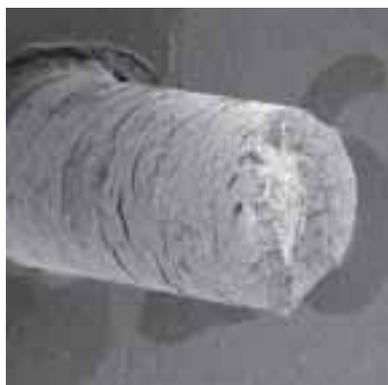
Extensive cracking and little reduction in area.

Figure 5 — Sample tested in caustic cleaning solution at 95°C.

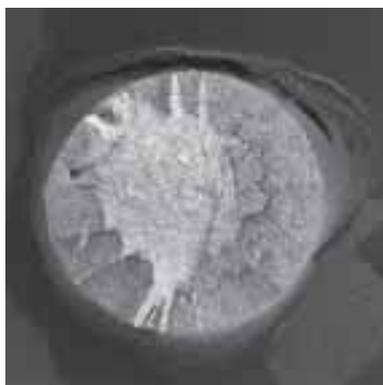
Fracture surface shows an outer brittle fracture and an internal ductile failure.

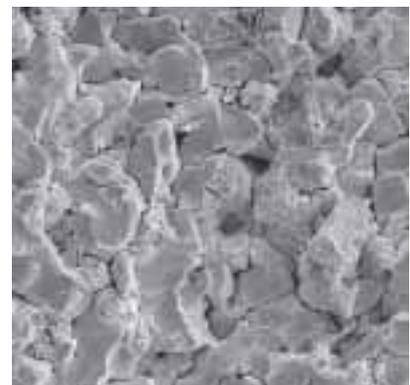
Micrograph of outer brittle fracture surface showing intergranular failure.

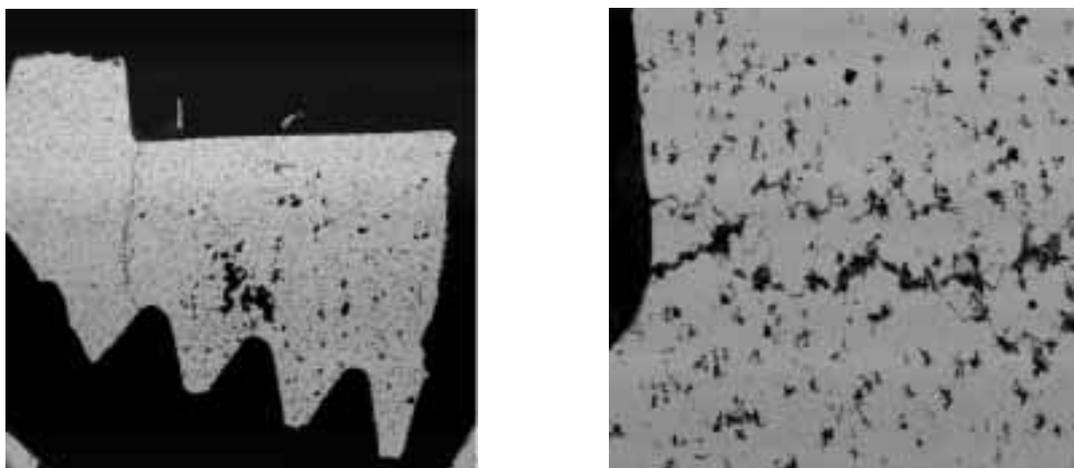
The major failure was on the right end of the sample, another crack is evident emanating from the last threaded section. The intergranular nature, and the carbon and ferritic microstructure are readily observed at the higher magnification.

Figure 6 — Caustic Embrittlement in a malleable cast iron fitting.

It is well documented that low carbon steel and, in particular, ferritic structures, are particularly susceptible to caustic embrittlement. The specific reason for this is not known but the practical evidence is overwhelming that higher carbon content and more pearlitic materials are less susceptible. Microstructure rather than carbon content appears to be the dominating factor. A good example is that of malleable, spheroidal graphite or nodular cast irons. Such materials are high in carbon yet have a microstructure that is essentially ferritic but with large flakes or nodules of carbon. In that condition there has been many failures even in quite benign conditions. An example of a ball valve

having failed at the thread is shown in Figure 6. The valve had been in place for several years in low temperature spent liquor and had literally fallen off in service. Both Alcoa and QAL have had similar failures with such materials and they are no longer used. Use of such materials for fittings and valves is frequently proposed because of their low cost; strict purchasing guidelines are required to prevent their ingress into the refinery. Information on the high susceptibility of this material to caustic embrittlement is not generally available across the Industry. The specific reason for this material being very susceptible is not known. There have been no specific laboratory studies. It is suspected that because the material essentially has a ferritic structure with large carbon nodules, significant localised potential differences accentuate the embrittlement process.

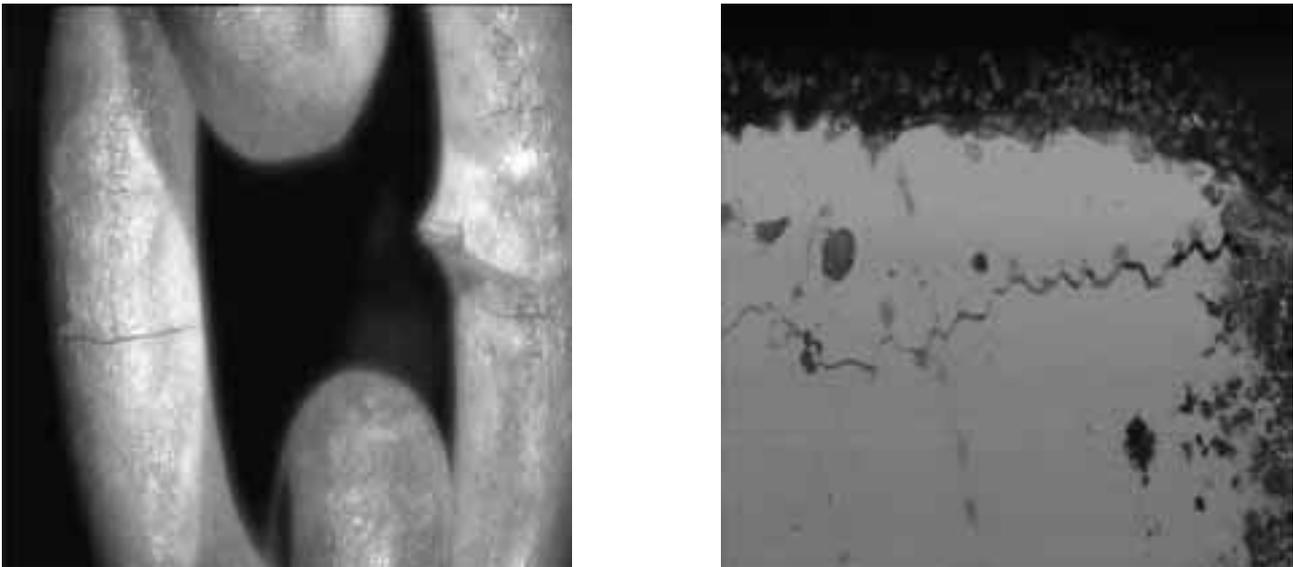
Figure 7 — Caustic embrittlement of a chain, several cracks are evident. The higher magnification shows the fracture area and a crack, intergranular in nature, is evident close to that fracture surface.

There has long been the view that slight differences in the microstructure/chemical composition might increase the susceptibility to caustic embrittlement as discussed by Champion (1957). As more refined testing procedures are developed, information is starting to emerge supporting this view, eg Liu et. al. (1994). High tensile materials appear to be more susceptible to caustic embrittlement. For example, there have been failures of high tensile chains whereas normal steel chains have not failed, Figure 7.
