SCALE INHIBITION AND CONTROL: RESULTS OF A FIVE YEAR FIELD STUDY INTO UNIQUE ELECTROCHEMICAL TECHNIQUES

Scaddan R* and Laurila T

Savcor Group Ltd

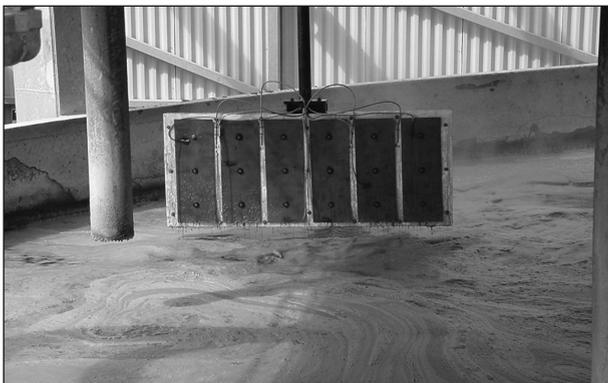
Figure 1.

A set of six mild steel test plates were mounted on a Teflon backboard to provide electrical isolation between the plates and electrical isolation from the steel support frame [Figure 1]. Teflon coated conductors and special reference electrodes provided the control and measurement connections to the Savcor Lmon control and measurement module [Figure 2]. The test plates were later modified to two sets of three for ease of handling in future tests.

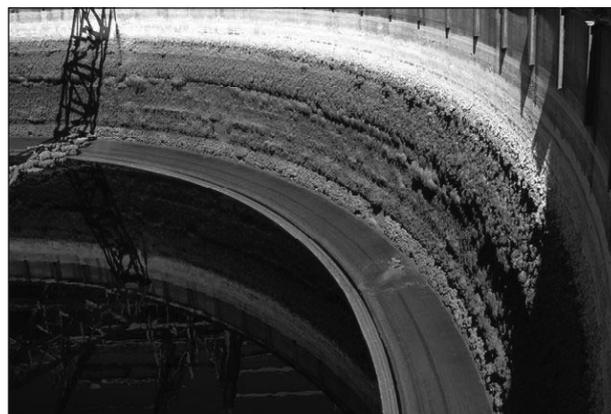
Figure 6.

The scale thickness was reduced by approximately 90–95% [Figure 7] when compared to the previous tank outage [Figure 6] with the only exception being the very top of the “tidal” zone where the surface crust was unchanged as expected because it is normally clear of the electrochemical protection zone.
