LABORATORY MODELLING OF EROSION DAMAGE BY VORTICES IN SLURRY FLOW

L.J.W. Graham¹, J Wu¹, G. Short¹, C. Solnordal¹, C. Wong¹, G. Brown², O. Celliers² and D Whyte²

¹ CSIRO Mineral Resources Flagship, Melbourne, Victoria, Australia

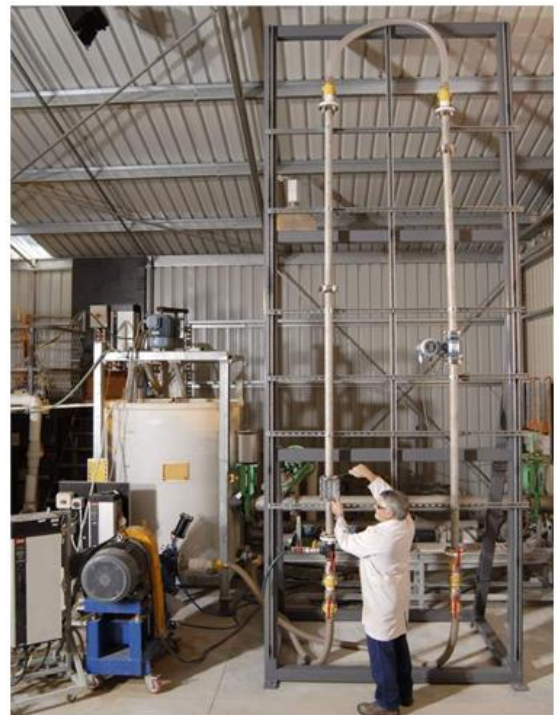
Figure 4. Photograph of CSIRO erosion rig

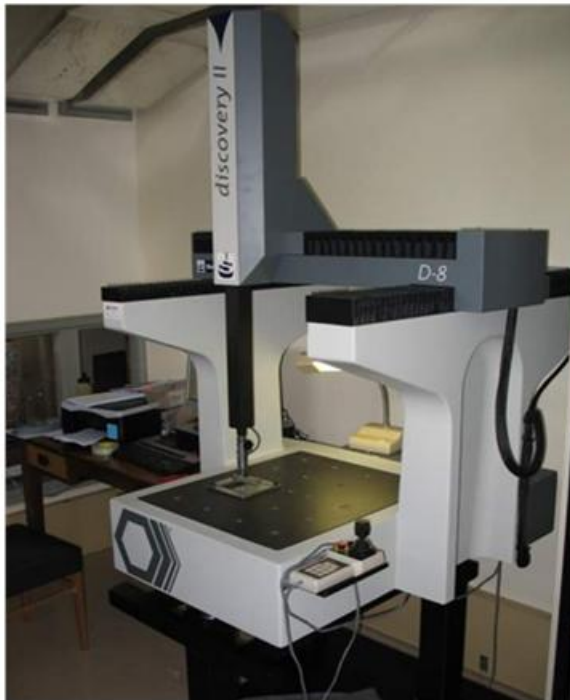
Figure 5. Sheffield Discovery II coordinate measurement machine (CMM) at CSIRO Fluids Engineering laboratory, 2011

All erosion measurements were made using the Sheffield Discovery 11 coordinate measurement machine (CMM) as shown in Figure 5. The repeatability of measurements made using the CMM was of the order of 3 μm .

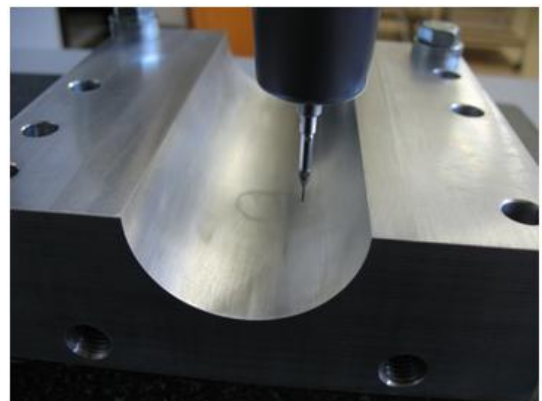
Figure 7. Measuring the uneroded condition of the experimental test section. The obstacle has been removed and a plug has been inserted to allow for probe access in the immediate vicinity of the obstacle

A pipe with an obstacle in slurry flow was studied as shown in Figure 6. The pipe was made from two pieces of aluminium (6061-T6) with a 53 mm diameter section machined out of each piece. This allowed for access for the touch probe of the coordinate measurement machine (CMM). The obstacle was a 16 mm diameter cylindrical stainless steel pin inset into the pipe and protruding approximately half way across the pipe cross-section. Using stainless steel for the obstacle ensured that it did not erode significantly during the test programme. A replaceable plug contoured to the shape of the pipe wall was also made in order to allow for good access for the CMM probe as shown in Figure 7. A 1 mm CMM probe was used for all tests. Table 1 shows the nominal test conditions.

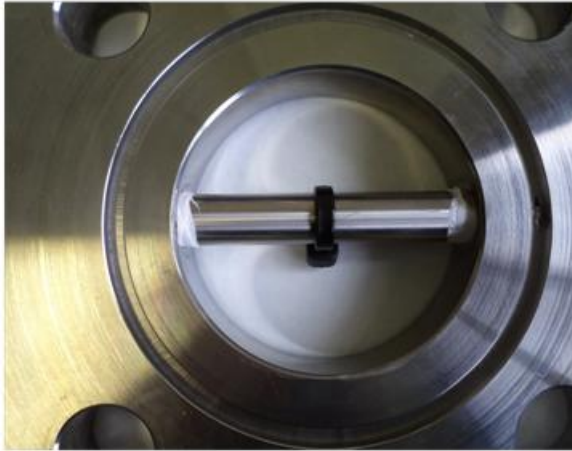
Figure 17 - Cable tie on cylinder in pipe sample, pre erosion

The purpose of this test was to explore another protrusion around a cylinder in pipe sample. In this case, the protrusion was 1.5 mm proud of the test piece and was a cable tie affixed to the cylinder. 316L stainless steel and 27Cr white iron samples were used. $25 \mu\text{m}$ silica was used as the erodent particles. The superficial velocity was 3.4

m s^{-1} . A photograph of the stainless steel sample before erosion is shown in Figure 17.

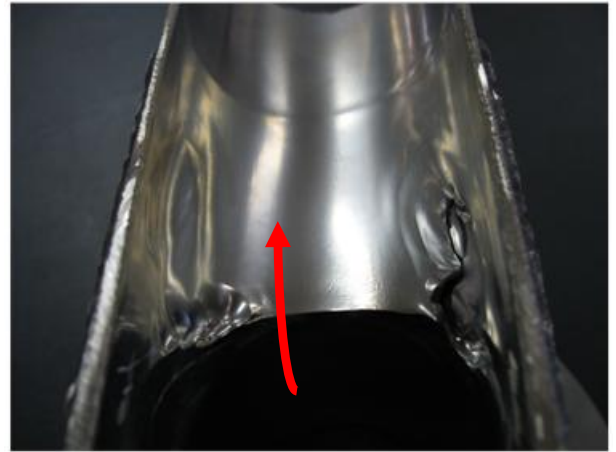
Figure 23. Erosion damage on tee. Arrow indicates flow direction

It was also observed that erosion occurred on the tee itself in locations near the pipe junction as shown in Figure 22. A photograph of this erosion is shown in Figure 23. Again, reducing or removing the vortex action may reduce this erosion.
