OBSERVATIONS ON EROSION PATTERNS IN BAYER SLURRIES

O.C. Celliers

Alcoa, Cockburn Rd, Naval Base WA 6165, Australia.

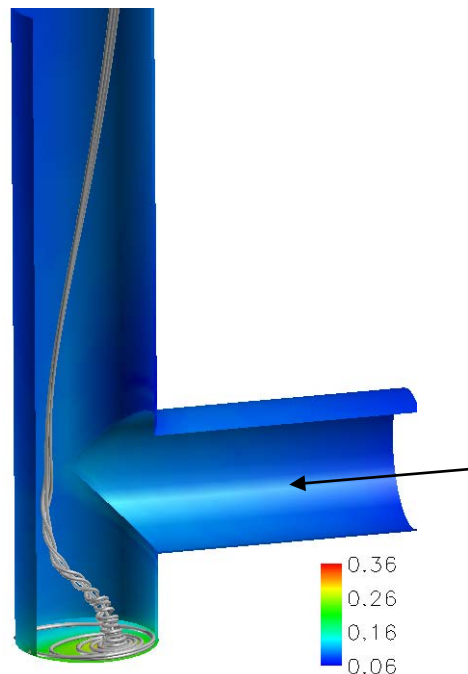
Figure 19. CFD model of vortex in flow

Figure 19 shows a schematic layout of a blind T that has been found to be susceptible to vortex erosion. Notice that the part of the vortex that is in contact with the equipment is the apex.

If vortices and standing turbulence are involved, the notion of impingement angle becomes a gross oversimplification. At the apex of a vortex acting perpendicular to a surface, such as in Figure 19, the impingement angle should be zero, but along the sides of a vortex such as a horseshoe vortex at the cutwater of a slurry pump volute, the impingement angle will change with the depth of the gouge. It looks likely that a range of impact angles are involved as erosion gouges develop.
